Robin Engine Oil Leakage Service Advisory March 2013

There have been instances where the Robin Subaru EH035 Four Stroke Engines used on the Strikemaster Strikelite Four Stroke Ice Auger has had moisture in the oil vent lines freeze and allow higher than normal internal pressures to occur and cause oil leaks to then develop when used in extreme frigid conditions. The following information has been provided by Strikemaster to help diagnose and repair this condition.

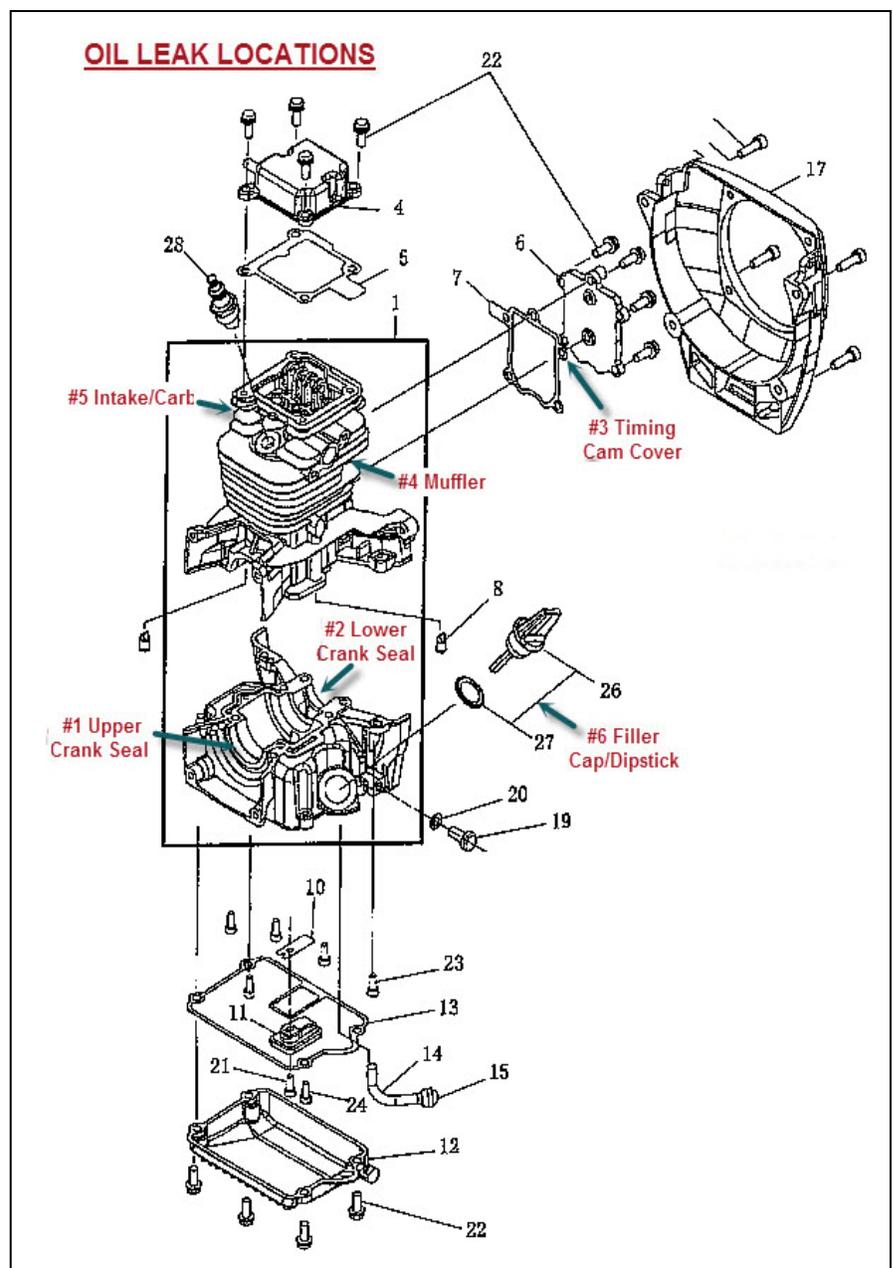
- The Robin Subaru EH035 engine only has 6 previously recorded locations from which oil can physically get from inside the engine to the outside. Causing an oil “leak”

- First we must determine which location the “leak” is originating from, most likely in the following locations:
 1. **upper crankshaft seal**
 2. **lower crankshaft seal**

3. **timing cam cover**
 4. **muffler**
 5. **intake/carb**
 6. **dipstick/ fill cap**
- The places we have most commonly seen “leaks” are from either the timing cam cover or the upper crank seal.

1 Upper crank seal

- If you look below the recoil through cylinder cover cooling fins, you will see a brown colored seal. It should be flush with surrounding aluminum housing.
- If the brownish colored seal is up out of housing, you will see the side of seal approx. ¼" and below it, exposed ball bearing.
- Normally this is from an overfill oil level or condensation building oil pressure.
- If this is the case not only does this crank seal need to be pressed back into housing, further steps like removing recirculation baffles in the oil system must be done to prevent a future reoccurrence. If you have notice an audio-able increase in noise level while running, this normally indicates that the upper seal has been forced out (See THE REPAIR below).

#2 Lower crank seal

#3 Timing cam cover

- This is located below the recoil assembly. If ever oil is visibly collecting on the fuel tank, this is normally the cause. The cam is mounted above flywheel under an aluminum plate which doubles as the ignition coil mount, this plate has a thin metal pressed coated gasket between plate and engine casting. If there is a leak here, normally excessive pressure is the cause again from overfill, or condensation. The gasket needs to be replaced and resealed, along with removing recirculation baffles in oil system.

#4 Muffler

#5 Intake carb

#6 Filler cap/dipstick

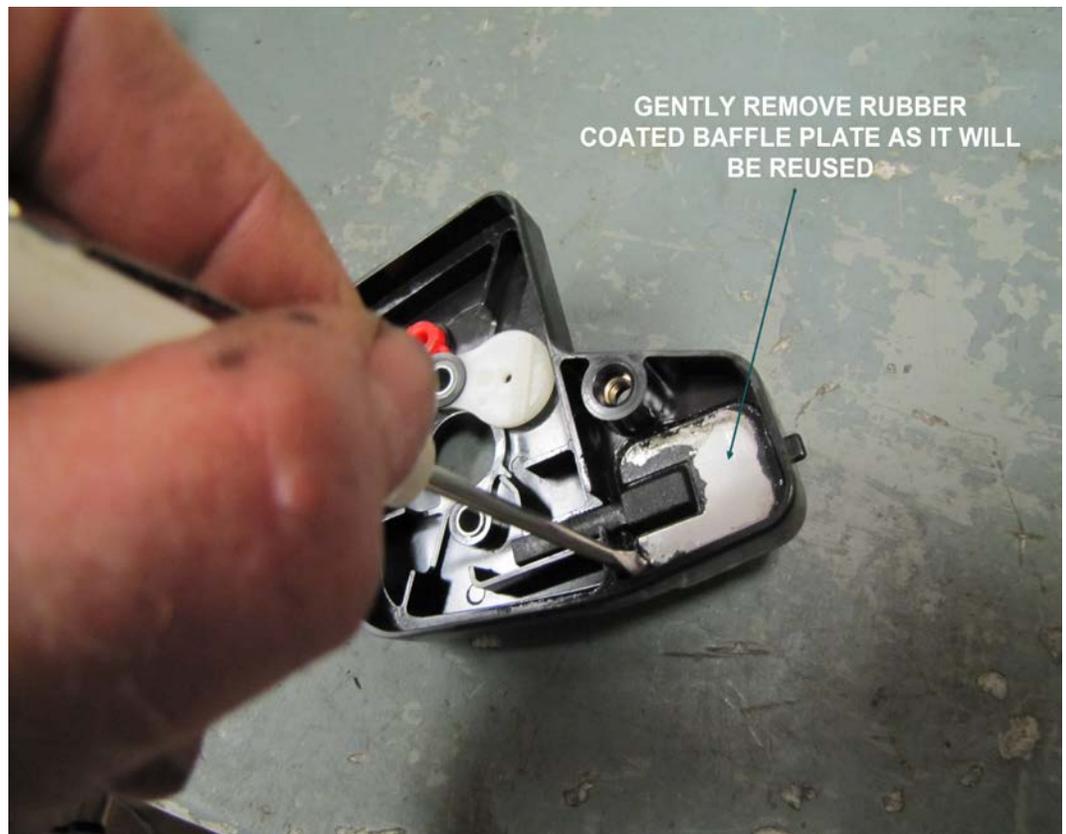
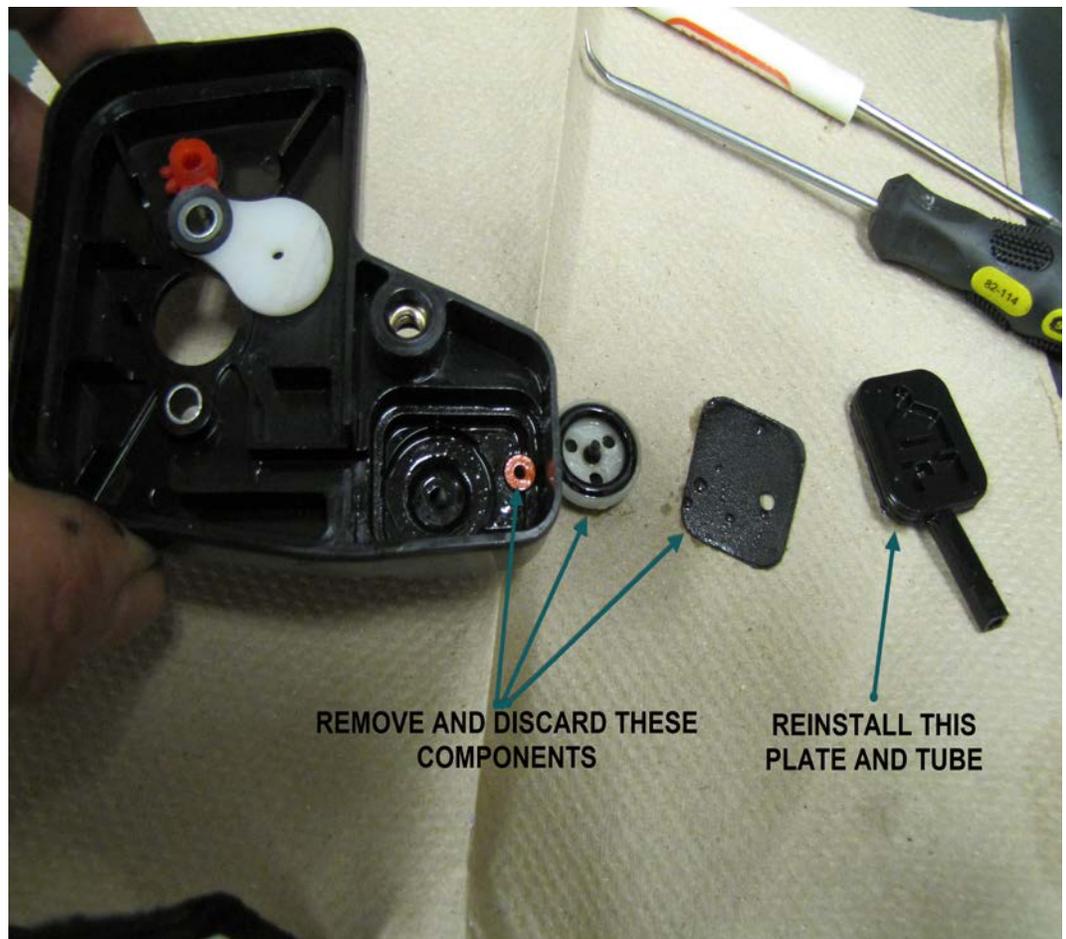
- Two vent lines enter from the back of the air filter assembly, one from the side of crank case, and the other from valve cover.
- Remove the air filter cover and filter elements. In the bottom right corner a rectangle shaped (aluminum and black rubber) baffle plate is pressed into the air filter/carb backing plate. (It will have an elongated tube pointing to left). Gently remove this outer baffle as it will be reused.

- Behind it, you will find a flat pressed baffle with a small 1/8" hole. Remove it
- Behind that will be a round white plastic disc with an O-ring. Remove it.

- Beside that will be a small red-orange "duck bill" baffle, recessed into housing. Using a pair of needle nose pliers or a hooked awl, remove this item as well.

- In every case, we tend to remove all baffles (except the outer rubber covered baffle plate) in the oil recirculation system from the corner of the air filter housing.

- Make sure that you remove the two rubber vent lines and using compressed air, blow these passages clear as you may find water inside one of these lines. This would freeze and block the return lines, thus causing internal pressures to build up, again.

- Once these 3 components are removed and the hoses and the housing is clean, reinstall the outer plate (with tube) back into backing plate.
- The air filter elements and cover can now be reinstalled. The "duck bill", the white disc with O-ring and the pressed gasket are not reinstalled and are discarded as they will not be used any longer.
